EXPEDITION 'JOB 74'

An overview of Expedition 'Job 74' which carried Explorers Club Flag #118 to the wrecks of HMS *Prince of Wales* and HMS *Repulse*, South China Sea, May 13th – May 25th 2007.

Report compiled and submitted by expedition member and flag applicant Kevin Denlay, Fellow International 1998. (Page 1 of 28)

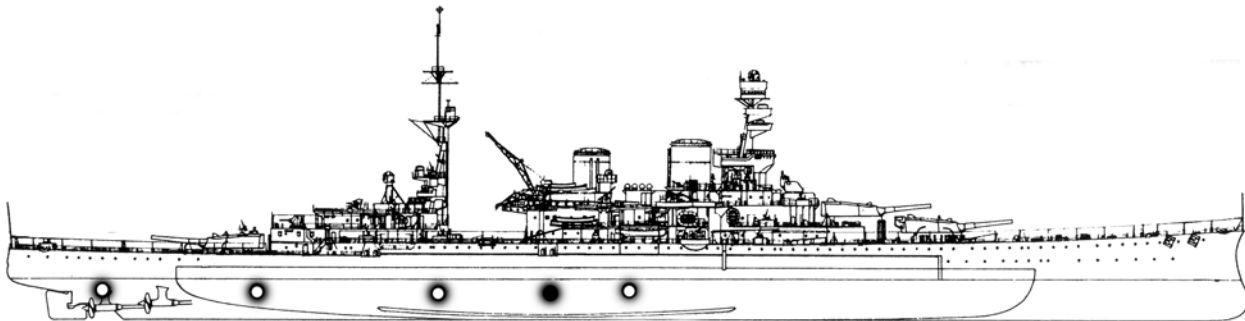
British sources record only five torpedo hits, as shown above.
Black solid circle on hull = Suspected starboard side torpedo hit.
Black outline circles on hull = Suspected port side torpedo hits.
